Make/Model	Date
Breezair ES/EV Control Modules (models with modular communication jack).	01/10/2024

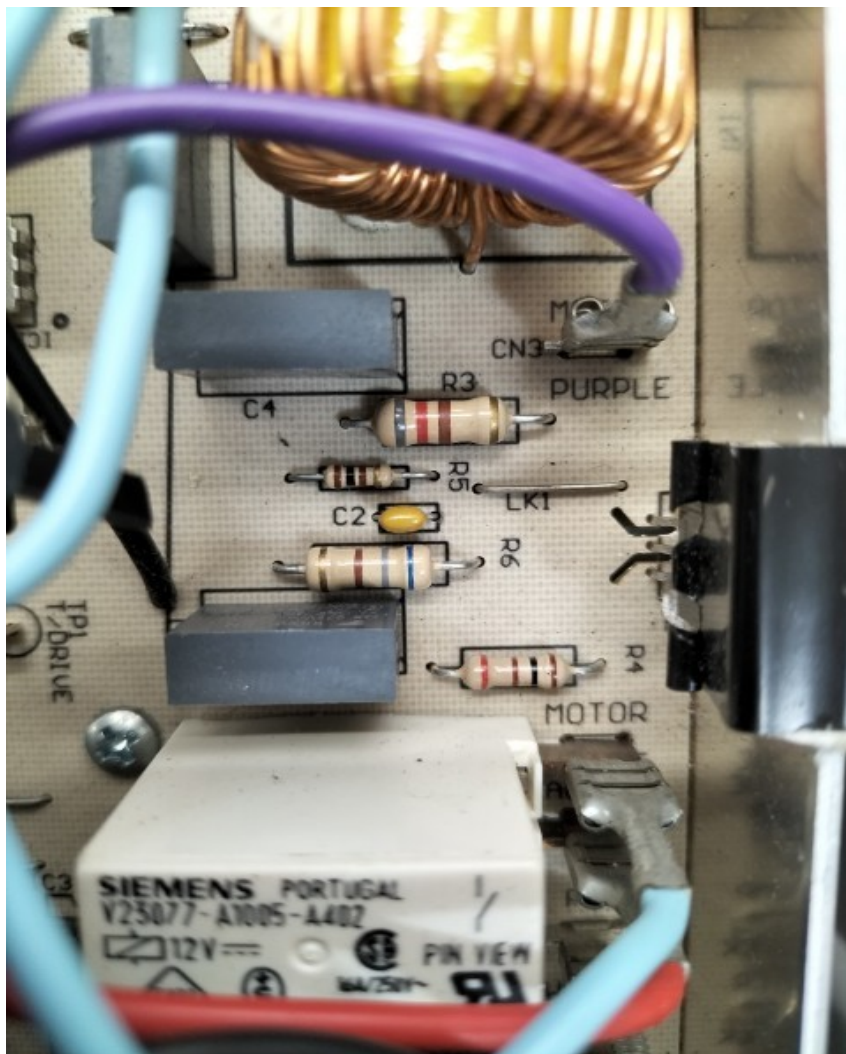
- The fan motor variable speed control circuitry can fail, damaging various components. This is usually caused by fractured solder joints around the pins of the fan motor triac.

Despite this, this circuitry can and does still fail, sometimes for no apparent reason, other times due to a fan motor over-current event (eg. a short in the windings inside the fan motor), or a fractured solder joint on one of the triac pins where it's soldered into the PCB.

One thing that's slightly unusual about the design, is that they've added a peak detector circuit to give feedback to the microcontroller with regard to the variable fan speed circuitry output. If the triac fails, or if the peak detector circuitry fails, this can trigger the microcontroller to go into the safety shutdown state.

It is not uncommon to see some resistors near to the fan motor triac burnt out, and the microcontroller in a safety shutdown. You can repair the speed control circuitry, but this won't get the microcontroller out of the safety shutdown. At this point, the board is a write-off, unless you can find a spare microcontroller from a donor board of the same model.

Figure 1: Photo of variable fan speed control circuitry

After repairing this circuitry, there's also the chance that the microcontroller will enter the safety shutdown state if the repair wasn't sufficient, as the output from the variable speed fan control circuitry may not be what the microcontroller is expecting to see. Experience has proven that it's best to test the repaired board with the fan set to the highest speed, as the output of the variable fan speed control circuitry doesn't appear to be monitored in this case.
